Local Area Management Investigation on Old  
Strandfontein Road, between Makro and SAB, Ottery  
TND57350

Department: Urban Mobility Directorate - Transport Planning and Network  
Management (South Region)

Date: 2026/03/16

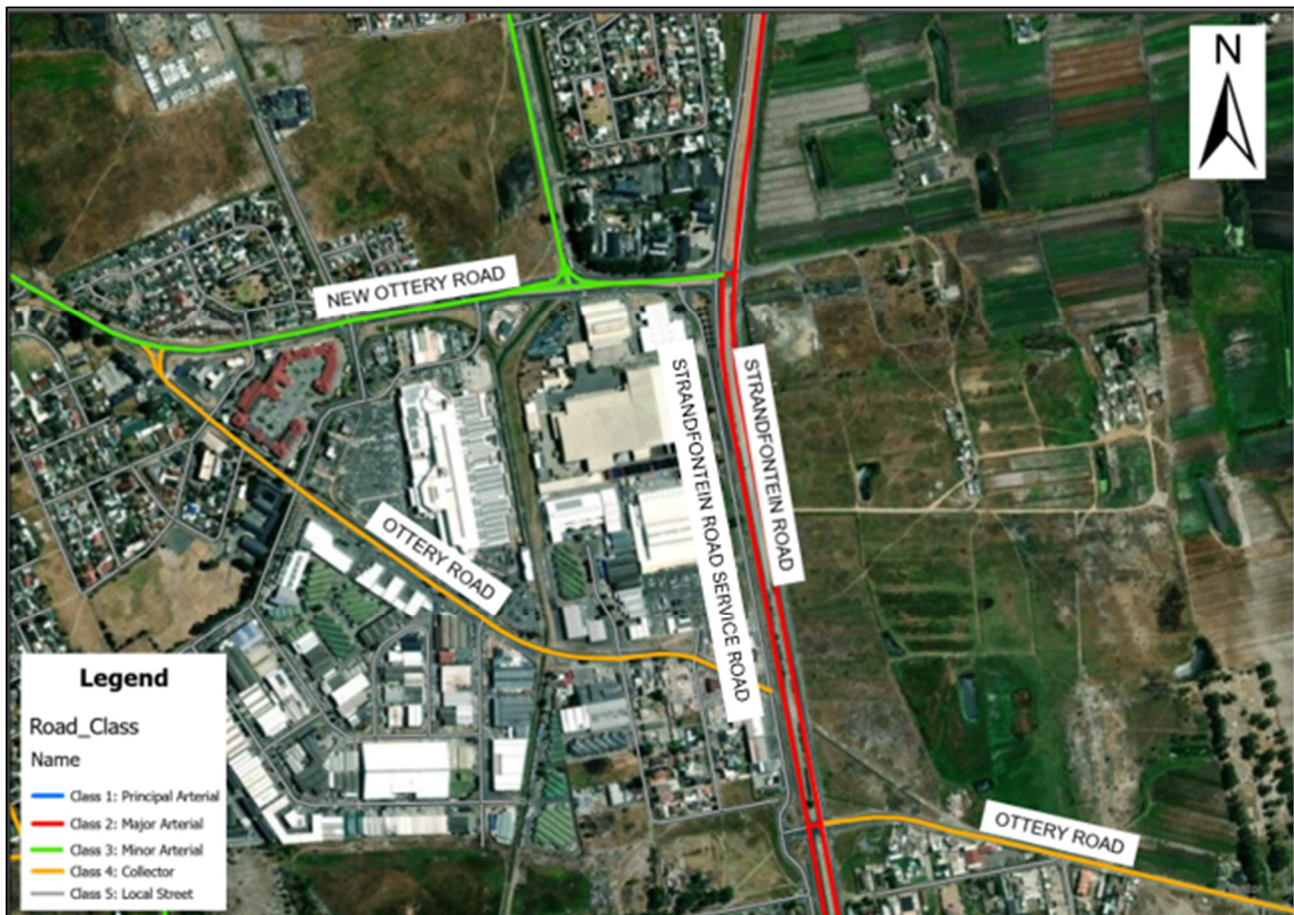
Figure 3: Road Classification

The existing road network in the study area as per the City of Cape Town's Public Right of Way map (2023) is illustrated in Figure 3. According to road classification, New Ottery Road is classified as a Class 3 minor arterial and Strandfontein Road (service road), is classified as a Class 5 local street.

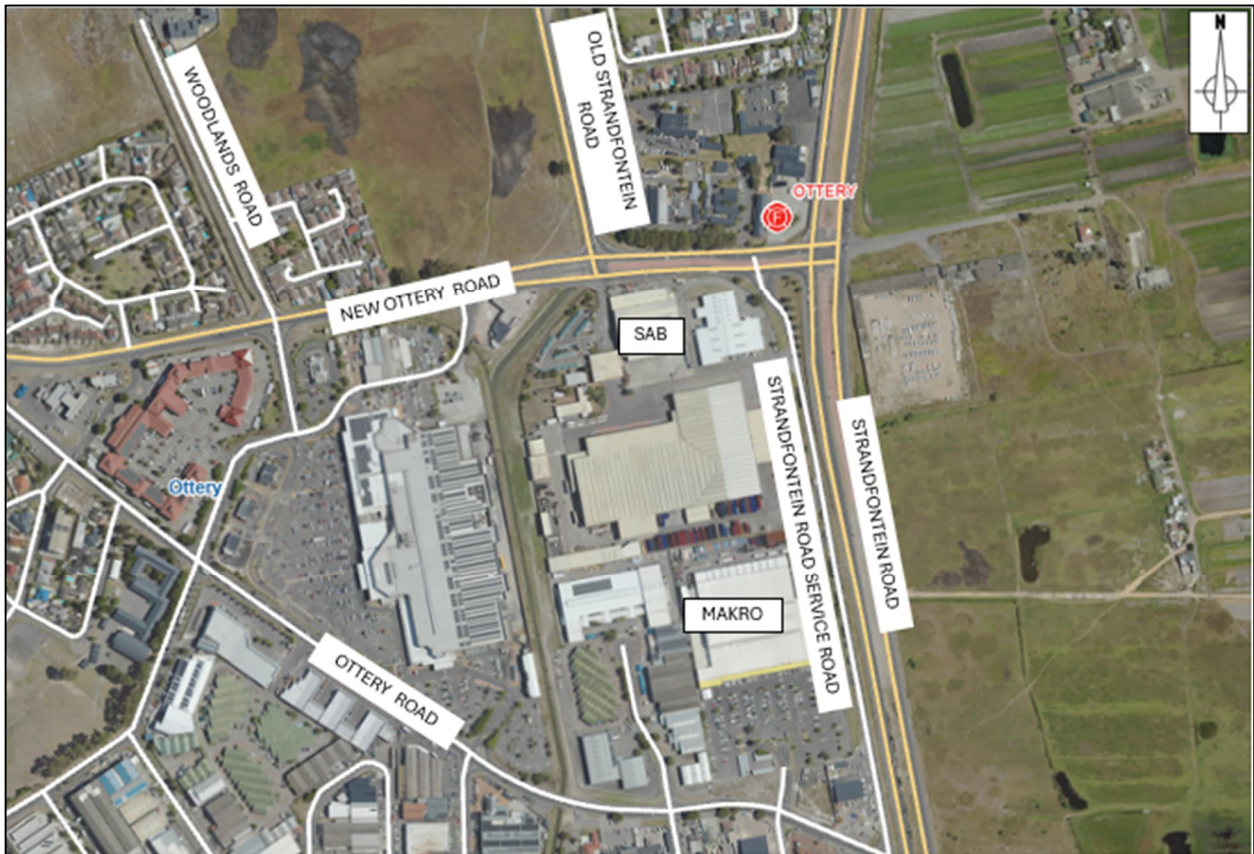
Figure 4: Existing Road Geometry

The existing geometry of the Strandfontein Road (service road) between Ottery Road and New Ottery Road is shown in Figure 4.

Strandfontein Road (service road) is a two-way roadway with one lane in each direction (northbound and southbound). The geometry of the road varies as noted below (starting from north to south):

- Between New Ottery Road and the business park access (approximately 80m), the road contains kerbs on both sides of the road with a sidewalk and guardrail along the western edge of the road behind the sidewalk. There is a partially paved portion of sidewalk on the eastern side of the road.

- Between the business park access and midway between Makro's receiving goods access and the Makro's shopping centre access (approximately 285m), the road contains kerbs and a non-continuous sidewalk along the western edge of the road, with guardrails along either side of the road. The guardrail along the western edge is positioned in front of the sidewalk.

- Midway between Makro's receiving goods access and the Makro's shopping centre access, and Global's parking area (approximately 140m), there are kerbs and a sidewalk along the western edge of the road and a guardrail along the eastern edge of the road.

- Between Global's parking area and Ottery Road (approximately 100m), there is a guardrail along the eastern edge of the road with no kerbs along either side of the road.

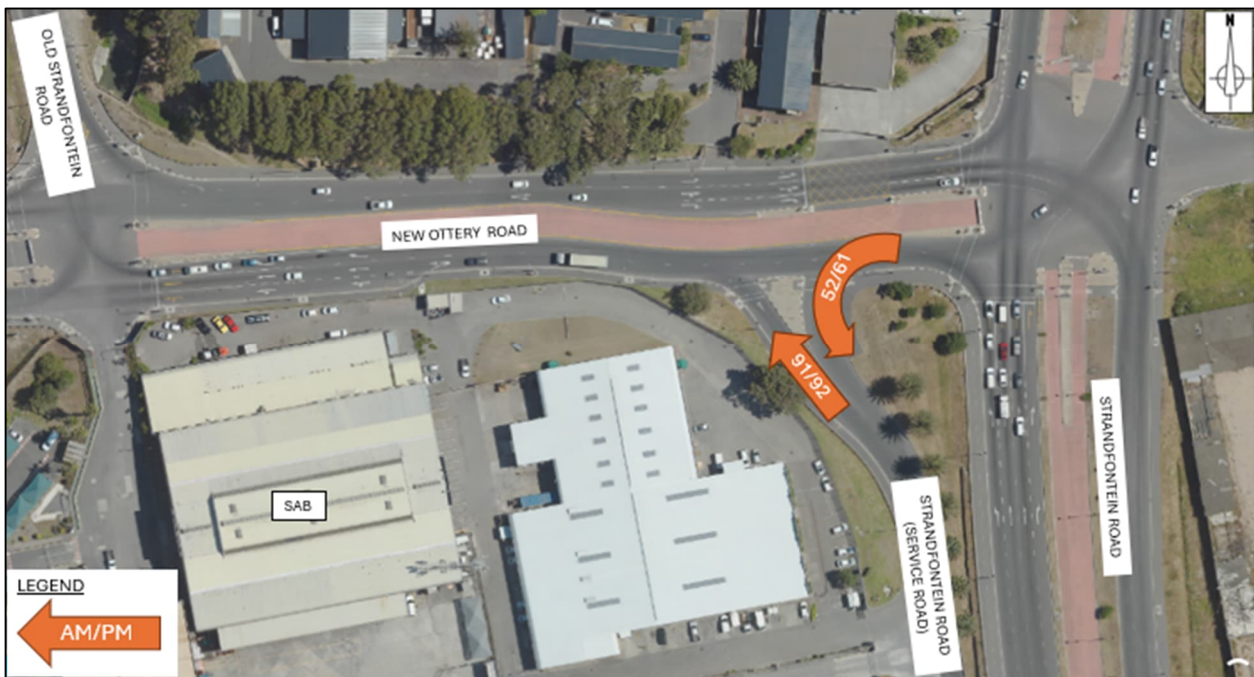
Figure 5: AM and PM Peak Hour Flows

A traffic count survey was conducted at the New Ottery Road/ Strandfontein Road (service road) intersection on Tuesday 26 August 2025 in the PM peak period from 16h00 to 18h00 and on Thursday 11 September 2025 during the AM peak period from 06h30 to 08h30, respectively. The AM peak hour was between 07h00 - 08h00 and the PM peak hour was between 16h15 - 17h15. The AM and PM peak hour flows at the intersection are shown in Figure 5.

- The highest traffic volumes travel northbound during the AM and PM peak hours.
- There was a fairly equal volume of traffic observed in the northbound direction during the AM and PM peak hours.
- The southbound volume of traffic is fairly low.

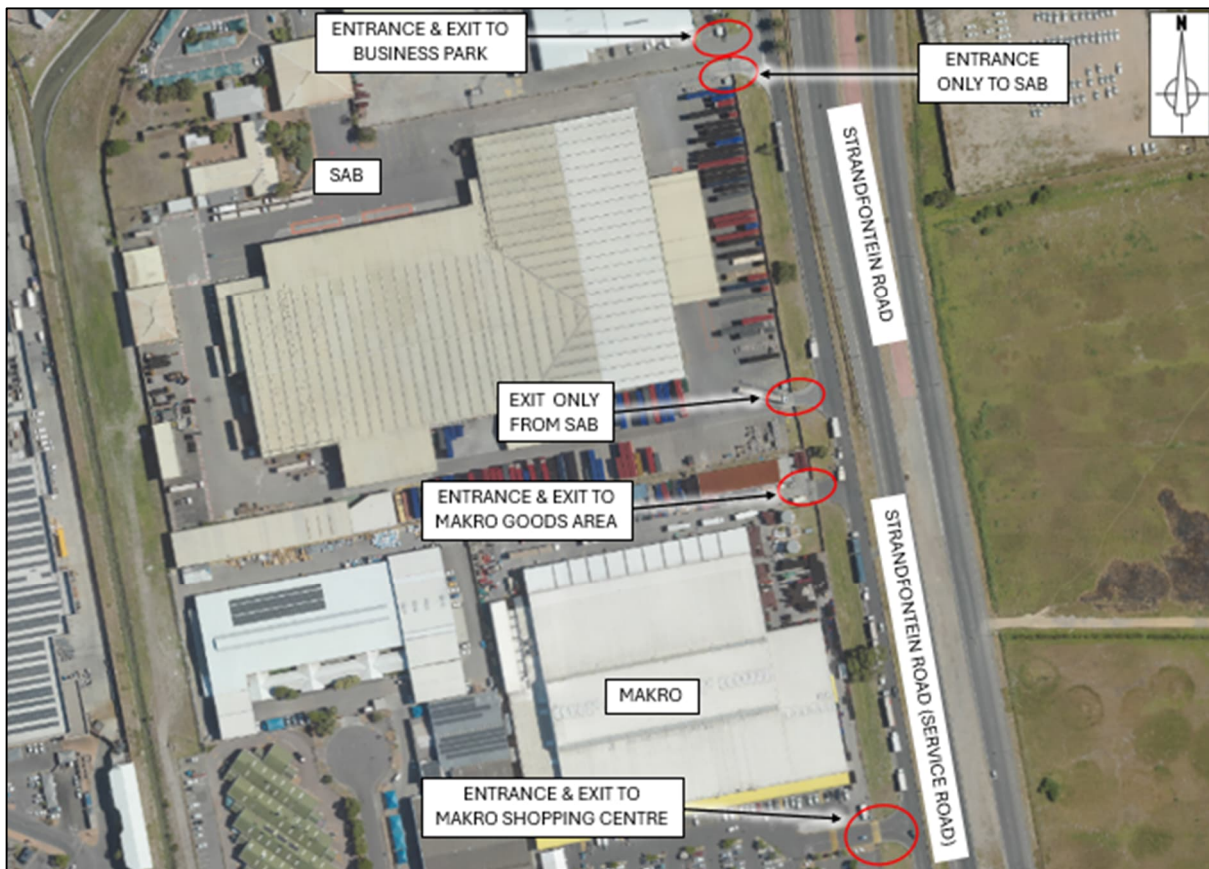
Figure 6: Accesses to Facilities along Strandfontein Road (service road)

- There is an access to a small business park (Independence Square) at the northern end of Strandfontein Road (service road).
- The accesses to the facilities along Strandfontein Road (service road) are illustrated in Figure 6.
- From the illustration in Figure 6, there is a long queue of heavy vehicles close to the entrance of Makro's goods area.

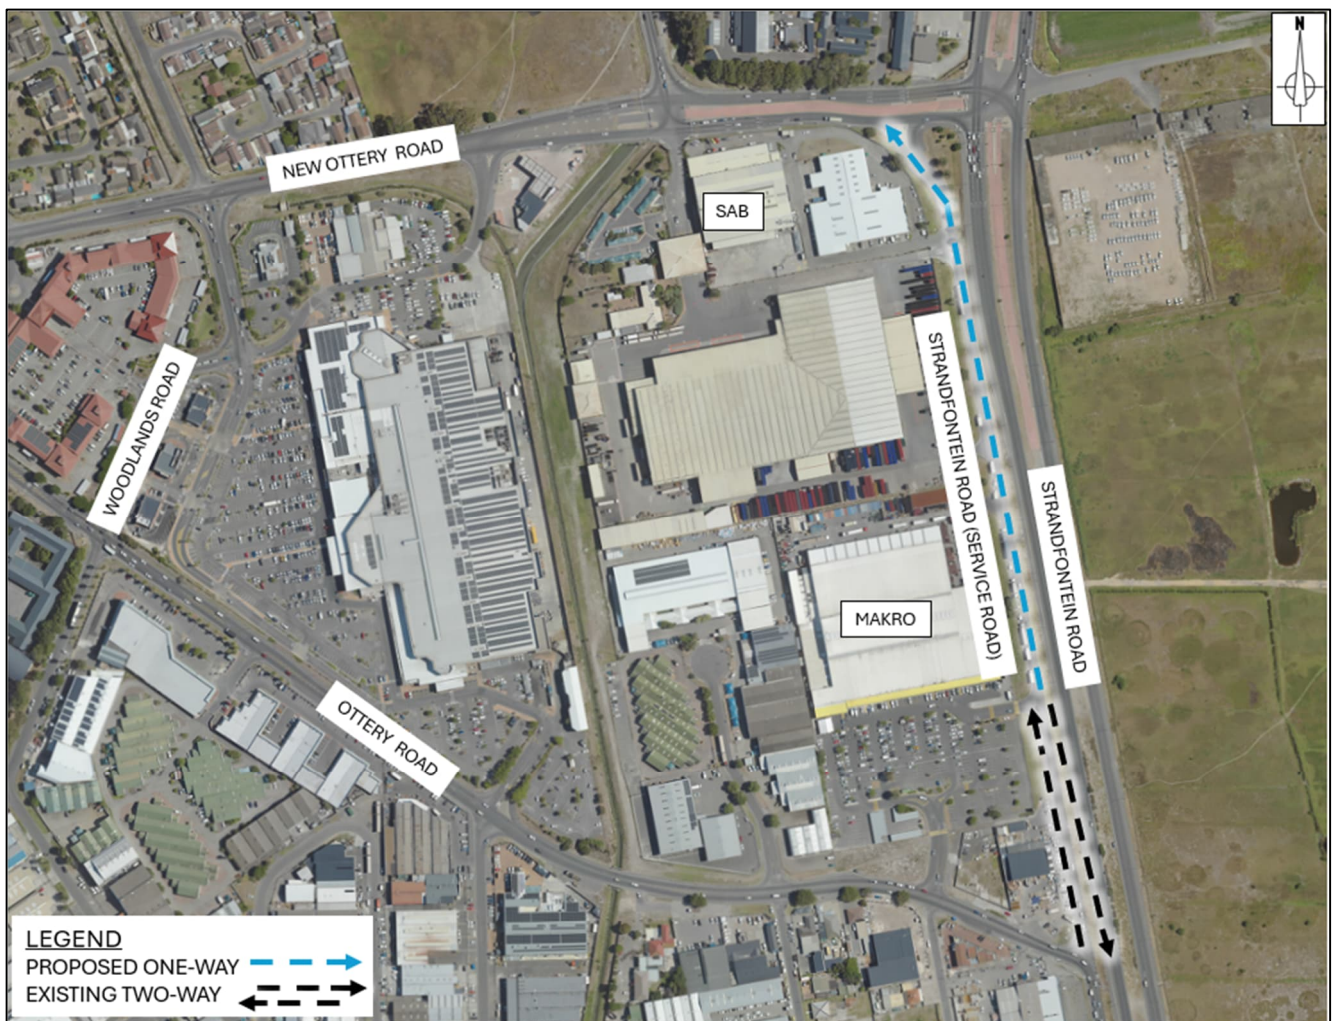
Figure 8: Proposed Northbound One-Way of Strandfontein Road (service road)

Based on the site observations, proposal 1 suggests converting the road into a one-way roadway in the northbound direction, between the Makro access and New Ottery Road, as shown in Figure 8. The two-way roadway would be retained between Ottery Road and the access to Makro shopping centre. This proposal will affect the business park access at the northern end of Strandfontein Road (service road). Therefore, the access to the business park would have to operate as a left-in-left out only.

Additionally, the left-in slipway at the intersection of New Ottery Road and Strandfontein Road (service road), would have to be closed off to prohibit access into Strandfontein Road (service road).

Proposal 1 suggests converting Strandfontein Road (service road) into a one-way roadway in the northbound direction, between the access to Makro and New Ottery Road. The two-way roadway would be retained between Ottery Road to the access to Makro shopping centre. This proposal will affect the access to the business park at the northern end of Strandfontein Road (service road). Therefore, the access to the business park would have to operate as a left-in-left out only. Additionally, the left-in slipway at the intersection of New Ottery Road and Strandfontein Road (service road), would have to be closed off to prohibit access into Strandfontein Road (service road).

Therefore, it would be recommended to opt for proposal 1 along Strandfontein Road (service road).

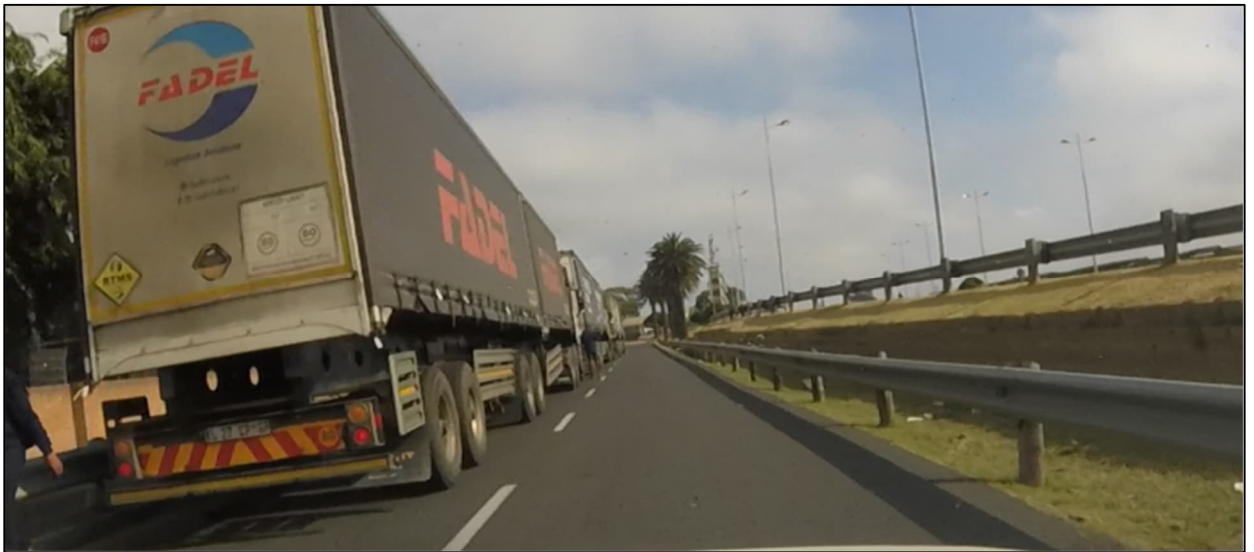
- There was a long queue of heavy vehicles parked along the western edge of the road, which completely obstructs traffic flow in the northbound lane (refer to Figure A1 and Figure A2). These heavy vehicles park along the roadway waiting to enter the SAB facility.

Figure A1: Heavy Vehicles Parked along the Western Edge of Stranfontein Road (service road)

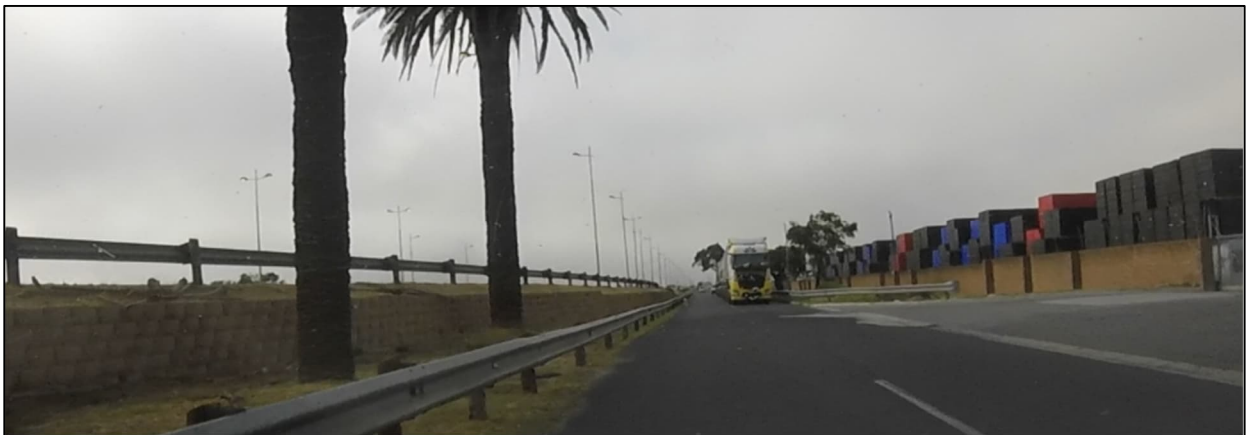
Figure A2: Heavy Vehicles obstruct Northbound Lane of Stranfontein Road (service road)

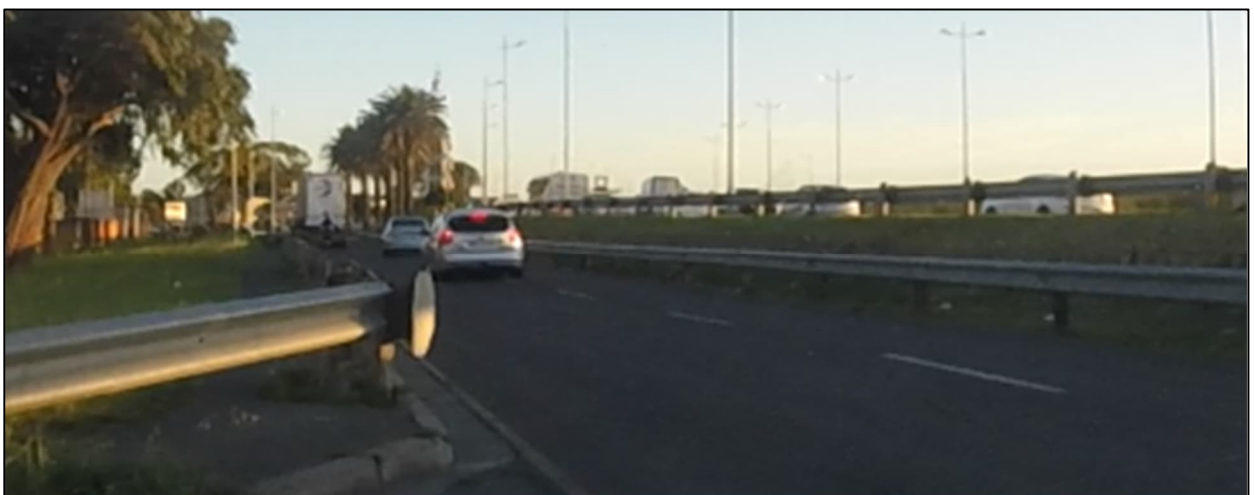
- Due to this obstruction, northbound traffic has to travel along the southbound lane which causes conflict between the northbound and southbound traffic (refer to Figure A3 and Figure A4).
- There is a gap in the guardrails along the eastern edge of Strandfontein Road (service road) as shown in Figure 7. This gap connects a pathway to the existing sidewalk along New Strandfontein Road to Strandfontein Road (service road). However, there are no sidewalks along the eastern edge of Strandfontein Road (service road).

Figure A3: Northbound Traffic Travels in the Southbound Lane due to Obstructed Northbound Lane

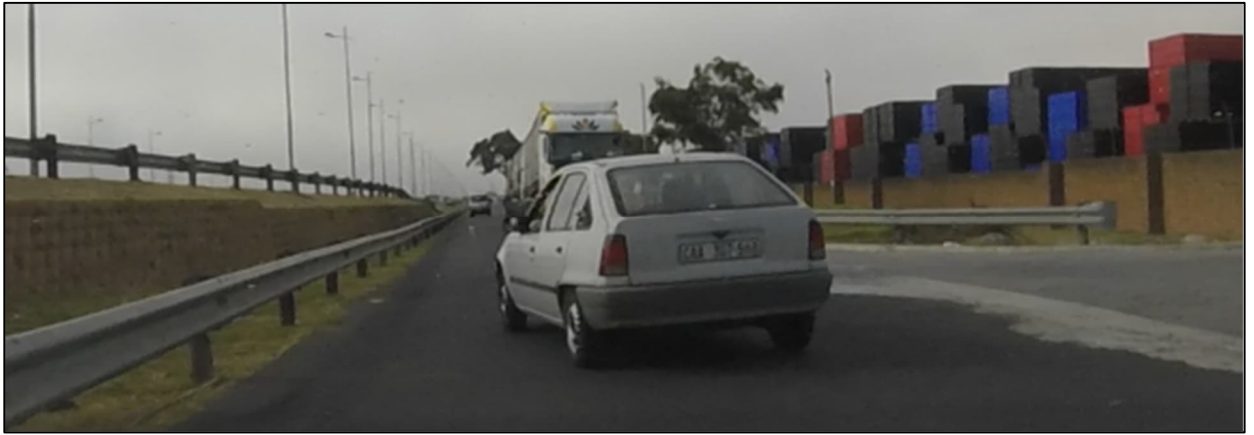
Figure A4: Northbound Traffic Travels in the Southbound Lane causing Conflict

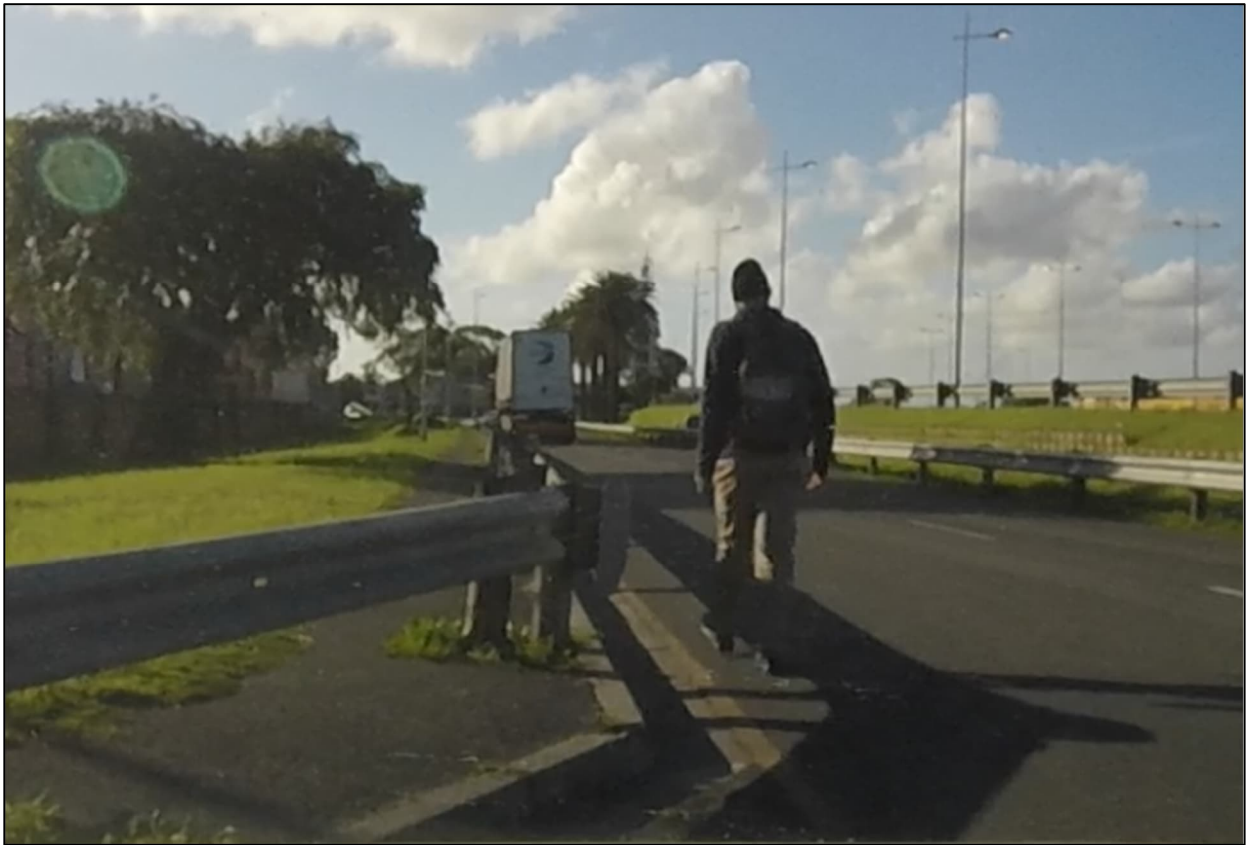
- There were a few pedestrians observed walking in the roadway along the Strandfontein Road (service road) as shown in Figure A5 and Figure A6.
- There were also some pedestrians observed walking along the sidewalk provided behind the guardrail, and would then have to climb over to continue their journey in their respective direction (refer to Figure A7).

Figure A5: Pedestrian Walking in the Roadway along Strandfontein Road (service road)

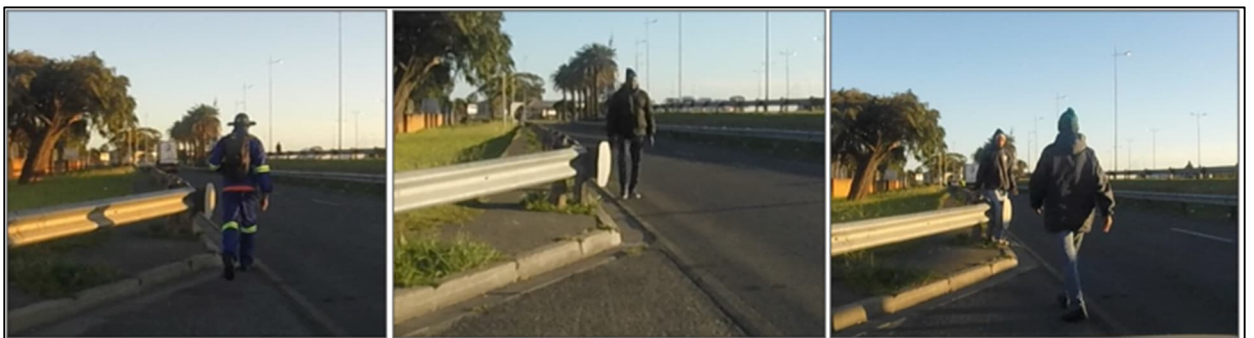
Figure A6: Pedestrians Observed Walking in the Roadway during AM Peak Period
