Local Area Management Investigation for the Traffic  
Management around Sun Valley Primary School, Sun  
Valley  
TND57416

Department: Urban Mobility Directorate - Transport Planning and Network  
Management (South Region)

Date: 2026/02/03

HHO Consulting Engineers

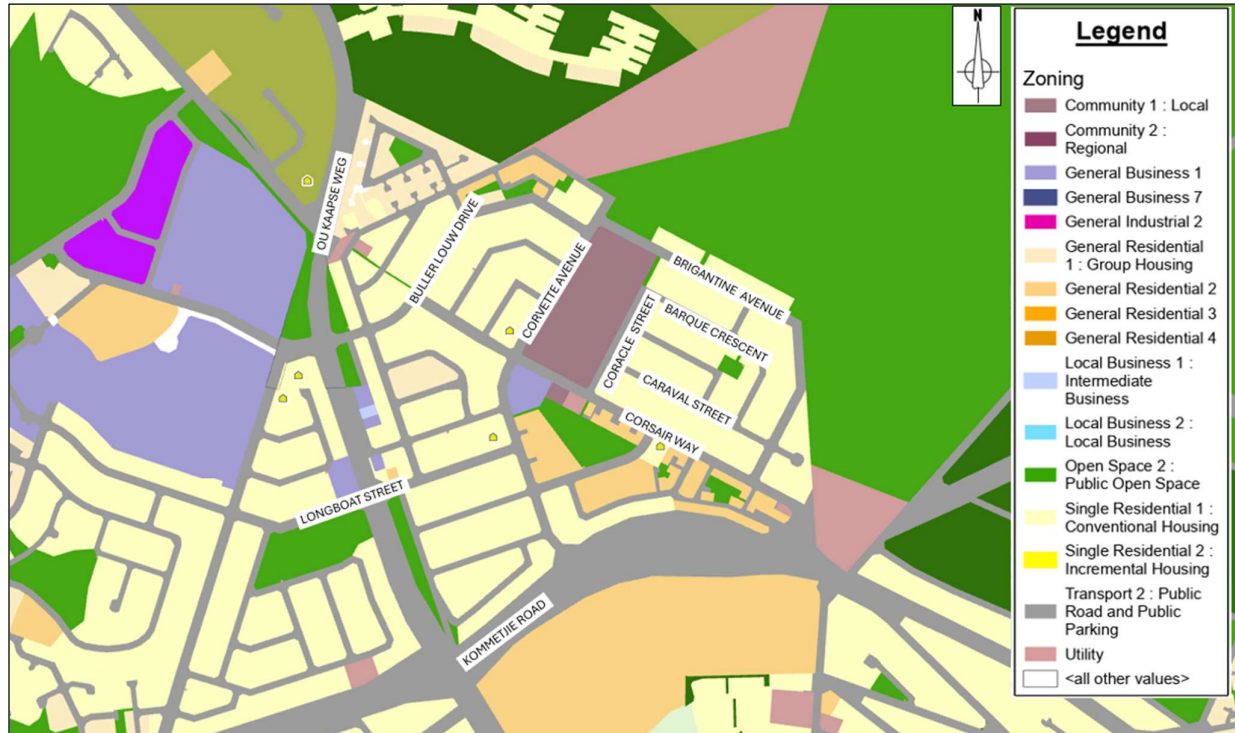
Figure 2: Land Use Schematic

The land use in the study area is predominantly single residential as illustrated in the Zoning Scheme from the City of Cape Town Map Viewer (refer to Figure 2). Therefore, it can be classified as a suburban area.

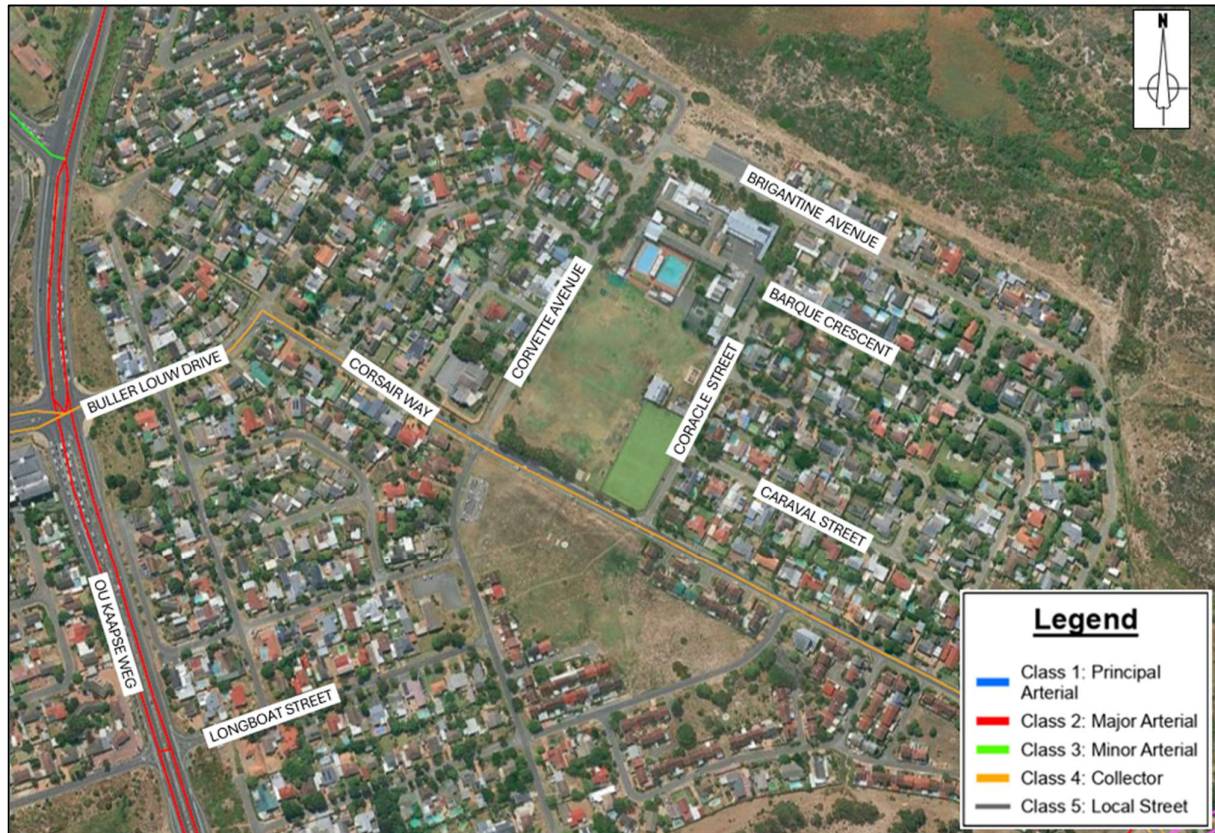
Figure 3: Road Classification Schematic

- Corsair Way is classified as a Class 4 collector road.
- Barque Crescent is classified as a Class 5 local street.
- Coracle Street is classified as a Class 5 local street.
- Corvette Avenue is classified as a Class 5 local street.
- Brigantine Avenue is classified as a Class 5 local street.

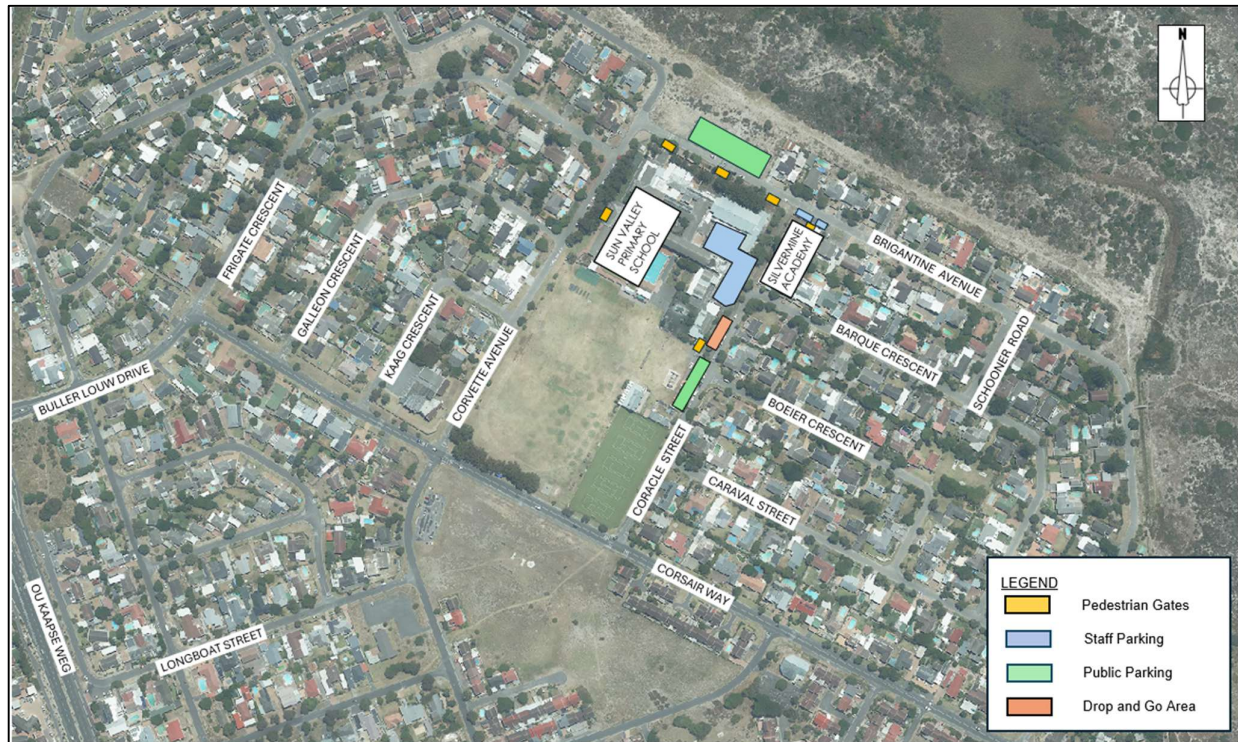
Figure 4: Existing Road Geometry

- Corsair Way is two-lane, two-way roadway (approximately 8.1m wide) south of the school and serves as a link between Ou Kaapse Weg via Buller Louw Drive and Kommetjie Road.

- Coracle Street is two-lane, two-way roadway, approximately 5.8m wide. This roadway is located east of the school and has a drop-and-go facility at the Sunbird Pre-primary and Sports access gates. It serves as a link between Corsair Way to Barque Crescent. The roadway has a sidewalk along the western edge and a footpath that leads to Brigantine Avenue. There are driveways on the eastern side of the road along with RM13 "NO PARKING LINES".

- Barque Crescent is two-lane, two-way roadway (approximately 7.1m wide) that connects Coracle Street into Barque Crescent. The roadway has driveways on both sides with RM13 "NO PARKING LINES" in certain areas. There are no sidewalks along either side of the road.

- Corvette Avenue is two-lane, two-way roadway, approximately 7.1m wide. The roadway is located west of the school with existing traffic calming in the form of a speed hump and a raised pedestrian crossing at student gate 1.

- Brigantine Avenue is two-lane, two-way roadway (approximately 6.8m wide) located to the north of the school, with existing traffic calming, road markings and pedestrian crossings with road signs in place. The road has a parking area close to the office block and two more access gates to the school. Another school in Brigantine Road, Silvermine Academy, has a parking area in front of the school.

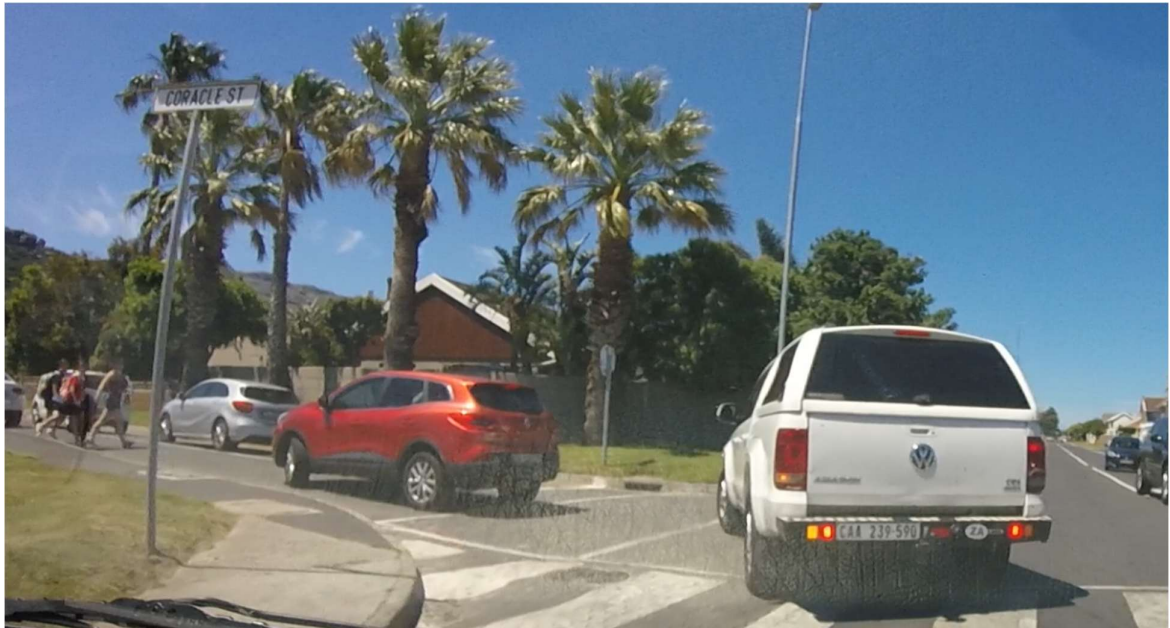
- Vehicles parking in Coracle Street, alongside of the road next to the school by entering the road at Corsair Way (refer to Figure A1), and parents leave their cars alongside the road to collect their kids (refer to Figure A2).

Figure A1: Vehicles enter from Corsair Way onto Coracle Street.

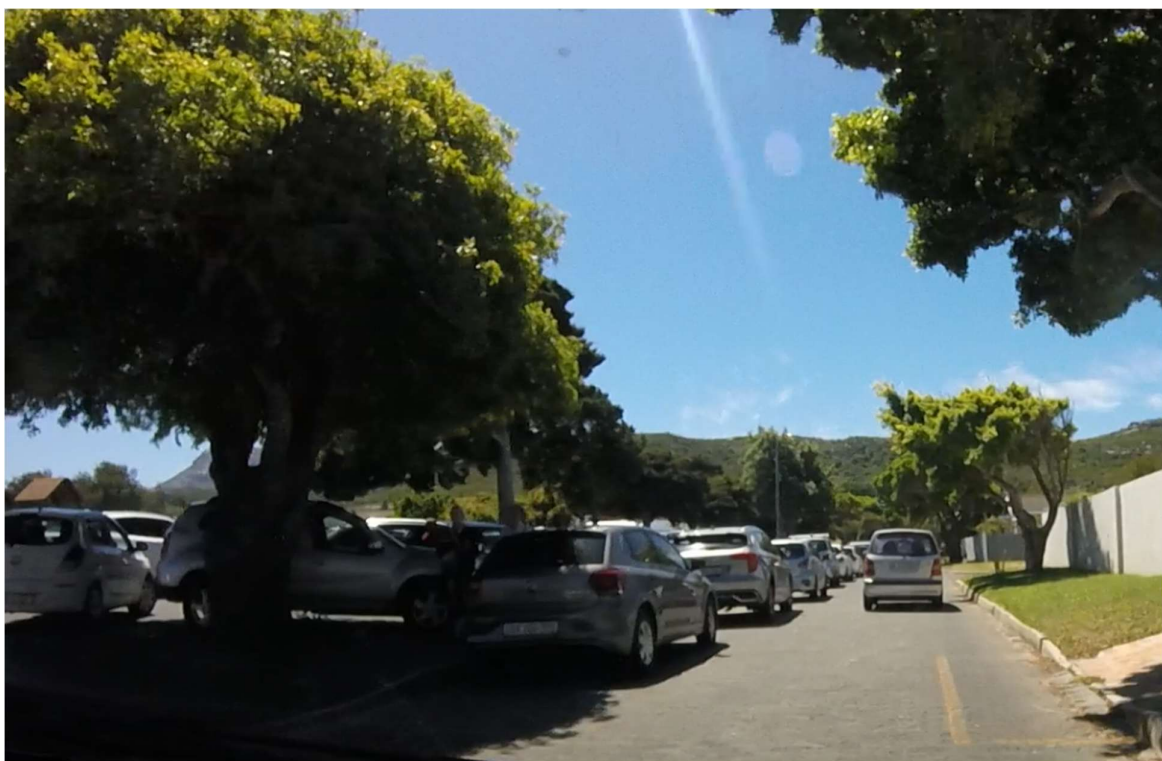
- Traffic, along Coracle Street into Barque Crescent, were very congested. The parking areas at the sports gate access and Sunbird Pre-Primary access were full (refer to Figure A3). There were vehicles blocking the middle of the parking area, to collect Pre-Primary school kids.

Figure A3: Vehicles parking along the Coracle Street next to parking area.

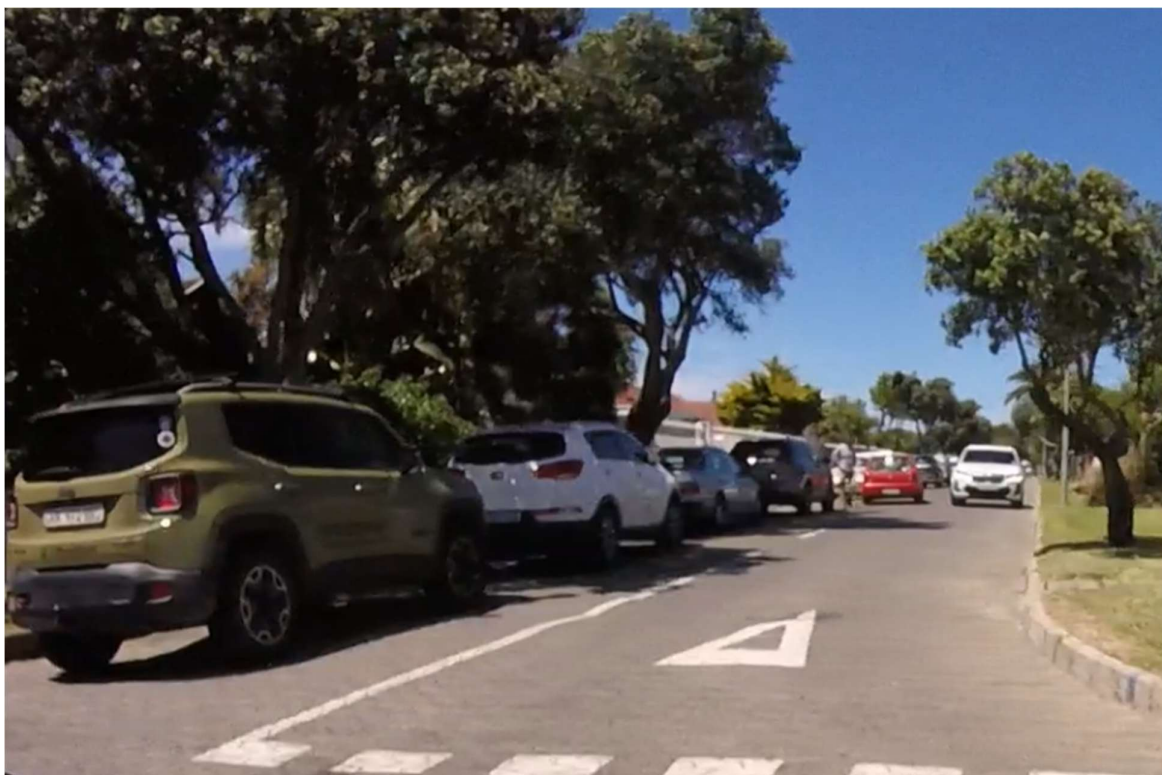
- There are two side roads that connect to Coracle Street which vehicles use for parking (refer to Figure A4) and exit out of (refer to Figure A5).
- From the observations, approximately 90% of vehicles travel northbound on Coracle Street to make it easier for vehicles to collect their kids and approximately 10% of vehicles comes southbound which causes obstruction to the traffic flow. Some vehicles drive slow in the queue and stops without pulling to the side of the road to pick up learners (refer to Figure A6). There were vehicles parked the RM13 "NO PARKING LINES" and opposite driveways.

Figure A4: Vehicles parking on side street of Caravel Street.

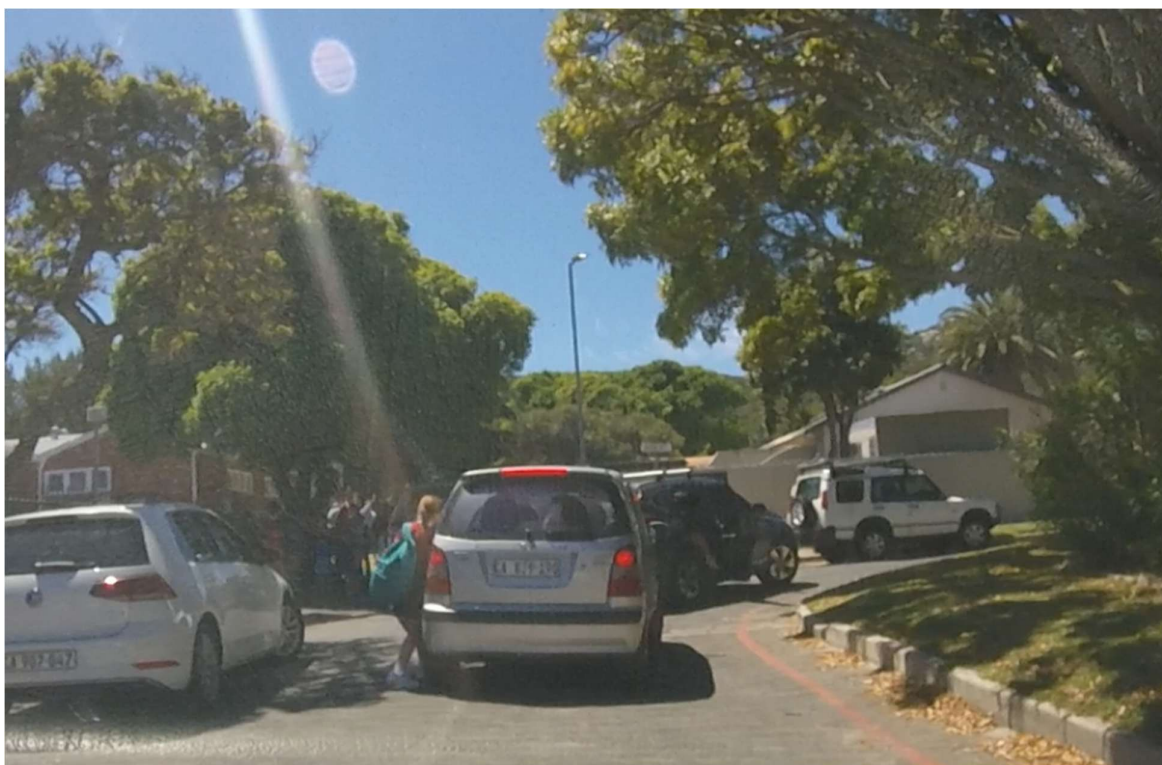
Figure A6: Vehicles stopping to collect learners on Coracle Street.

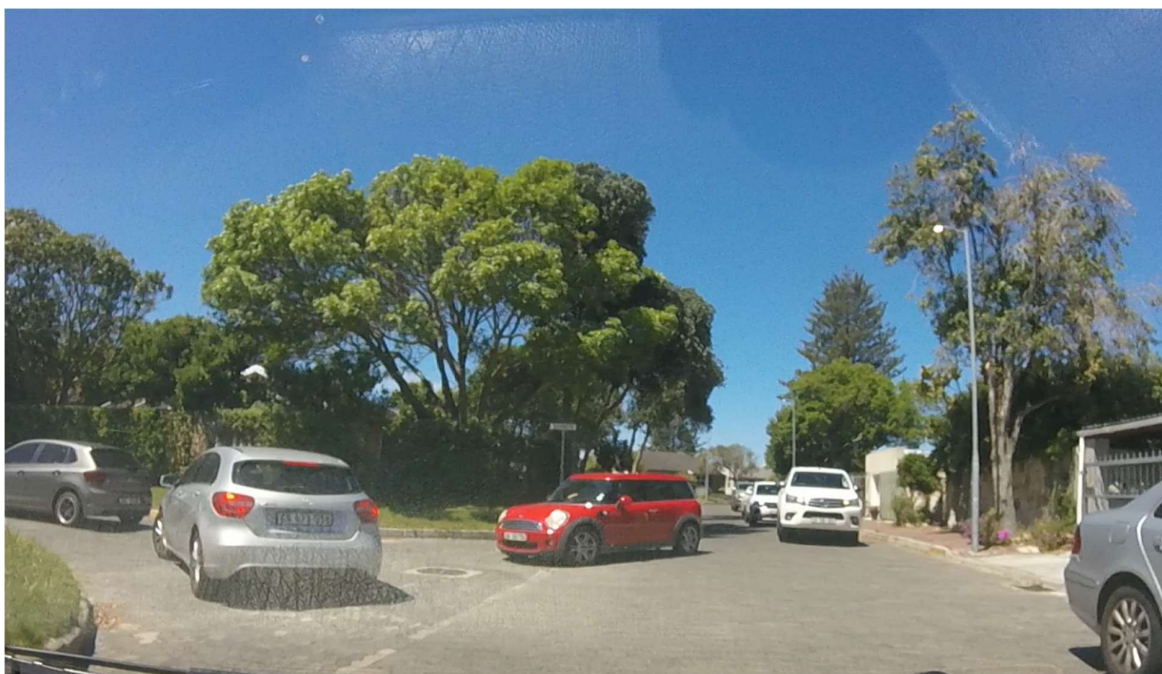
- Vehicles were observed parking and stopping along Barque Crescent to pick up learners from the school (refer to Figure A7), which also adds to the congestion experienced along Coracle Street. Vehicles then exit onto Schooner Road after collecting their kids along Coracle Street and/or Barque Crescent (refer to Figure A8).

Figure A8: Vehicles exiting Barque Crescent onto Schooner Street from collecting kids (using side street parking).

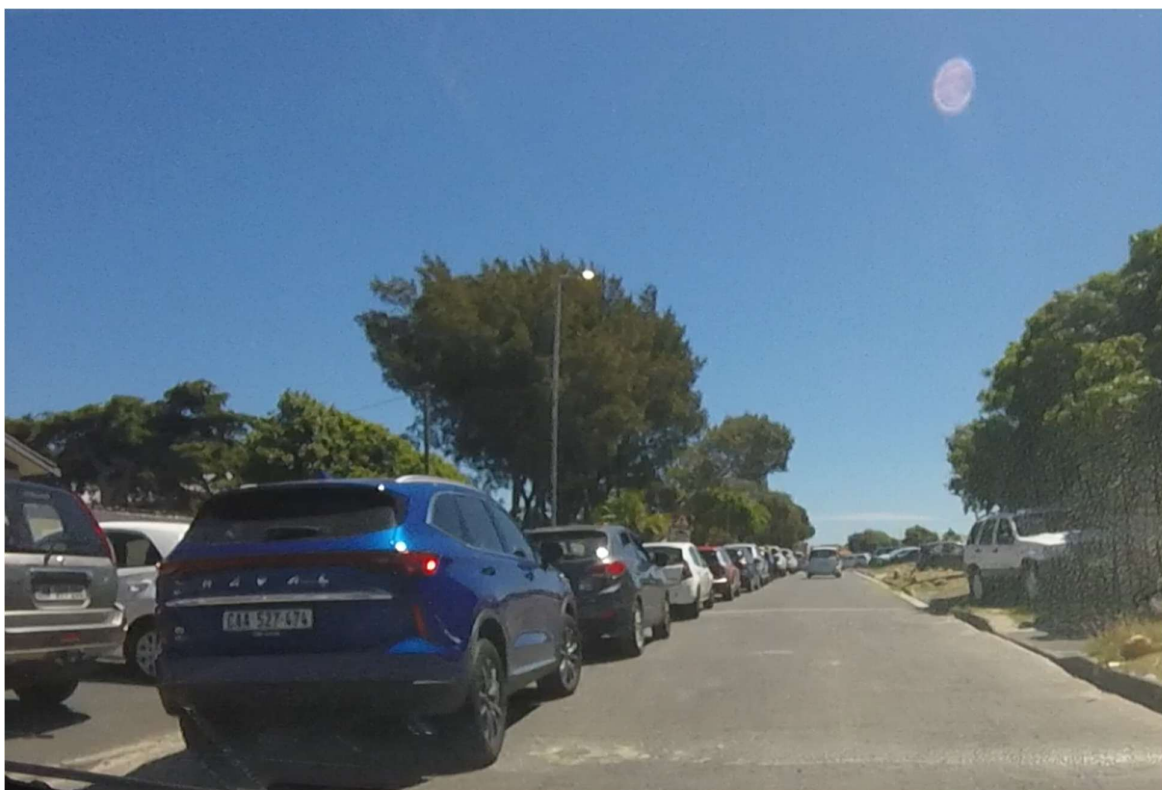
- Traffic volumes along Brigantine Avenue in the vicinity of the school and parking area very were congested. It was observed that vehicles were parking along the street  $\pm 270\text{m}$  from Corvette Avenue (refer to Figure A9). Traffic safety cones were placed along the road to keep the pedestrian crossing clear from vehicles parking on it. The parking area in front of Silvermine Academy and the parking area opposite the school was also fully parked (refer to Figure A10).

Figure A9: Vehicles parking along Brigantine Avenue.

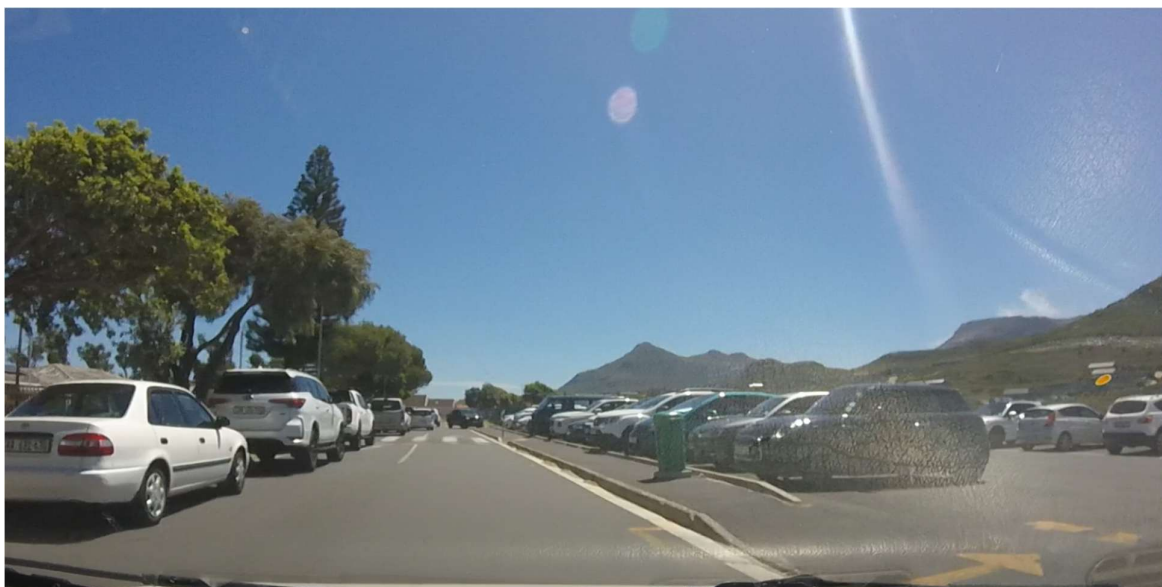
- The parking area opposite the school has a one-way in and one-way out for traffic to flow easier, but it was observed that vehicle would enter and exit at both accesses impeding the flow of traffic.

Figure A10: Parking area on Brigantine Avenue.

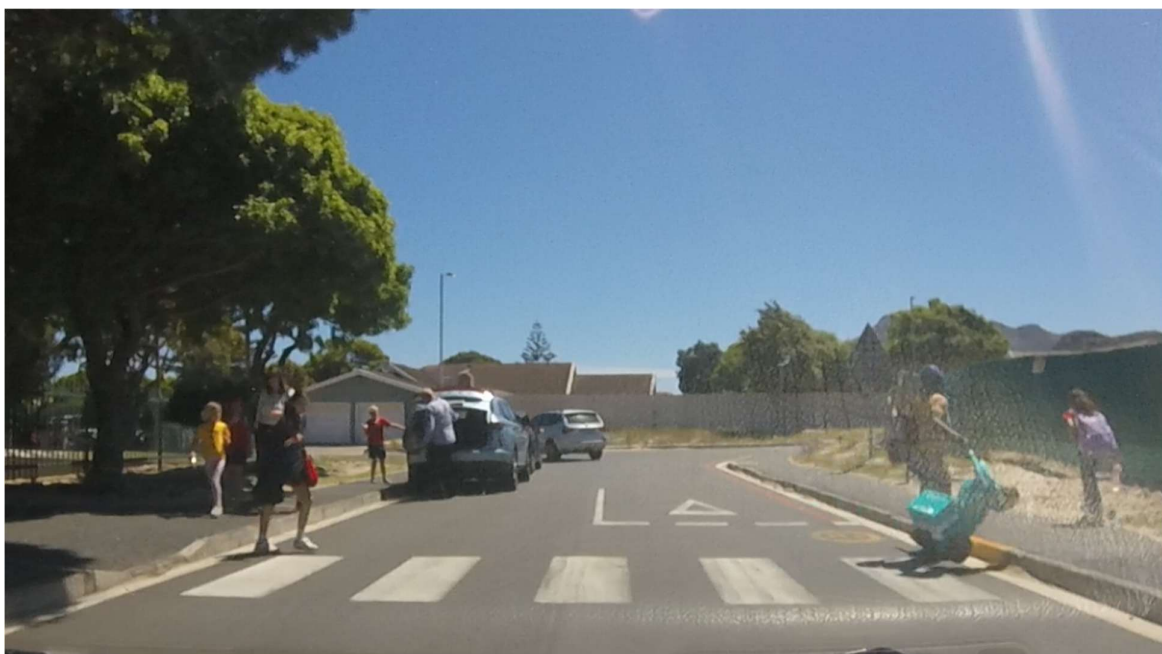
- Brigantine Avenue has two pedestrian crossings close to each other – one is a midblock pedestrian crossing, close to Corvette Avenue/ Brigantine Avenue intersection (refer to Figure A11), and the other is a raised pedestrian crossing. The raised pedestrian crossing has all necessary road signs and road markings in place except the R2.1 YIELD TO PEDESTRIANS" sign. The midblock pedestrian crossing lacks the necessary road signs and universal access.

Figure A11: Mid-Block Pedestrian Crossing on Brigantine Avenue.

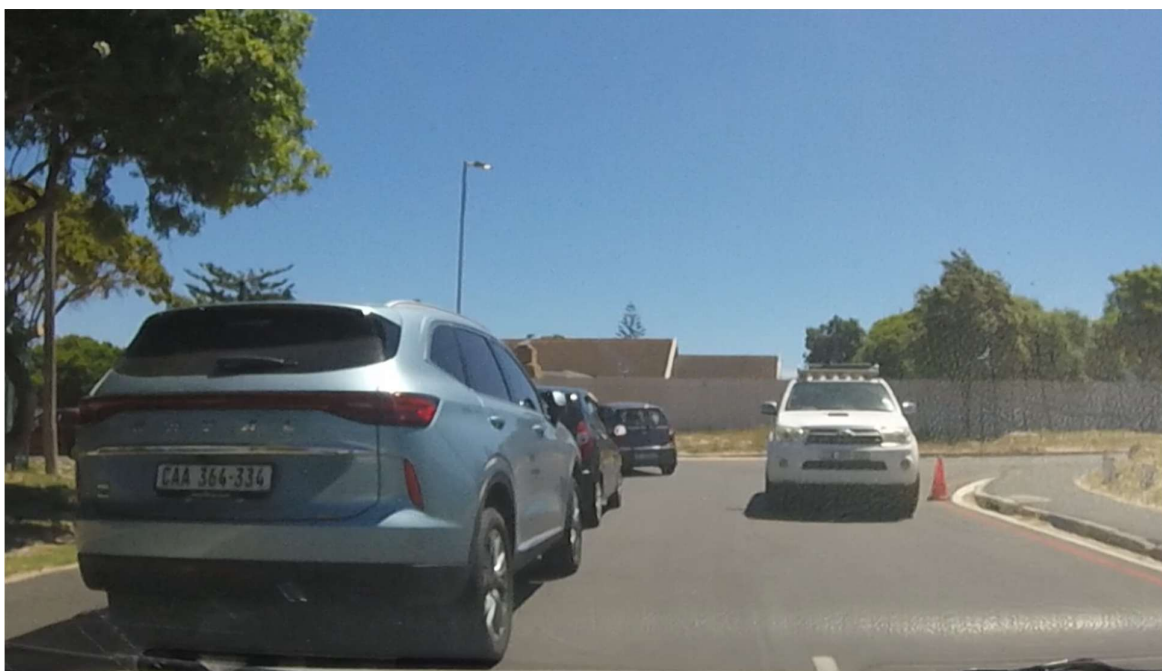
- There were vehicles observed parking very close to the intersection of Corvette Avenue and Brigantine Avenue (refer to Figure A12). Traffic cones were placed at the intersection to prevent cars of parking in the intersection.

Figure A12: Vehicles parked very close to the Brigantine Avenue and Corvette Avenue intersection.

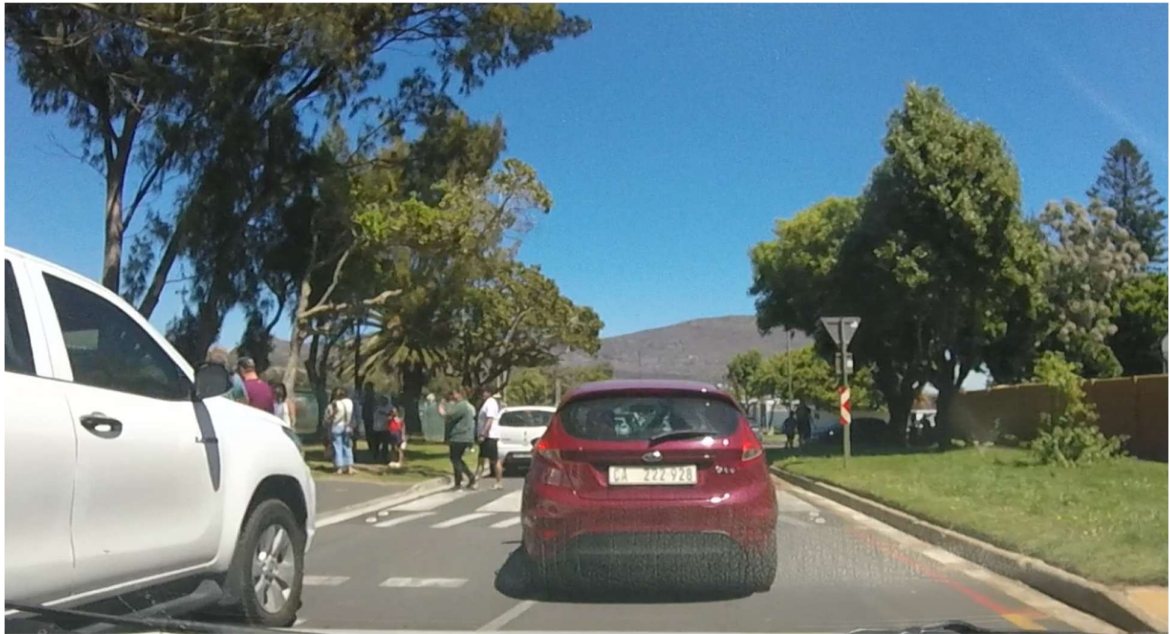
- Corvette Avenue provides access to student gate 1 and has traffic calming in the road in the form of a speed hump and a raised pedestrian crossing at the gate (refer to Figure A13). It was observed that vehicles park along Corvette Avenue, from Brigantine Avenue to Kaag Crescent along the side of the school to collect their kids (refer to Figure A14). Vehicles were also observed parking along roads perpendicular to Corvette Avenue, such as Galleon Crescent (refer to Figure A15).

Figure A13: Raised Pedestrian Crossing on Corvette Avenue at Student Gate 1

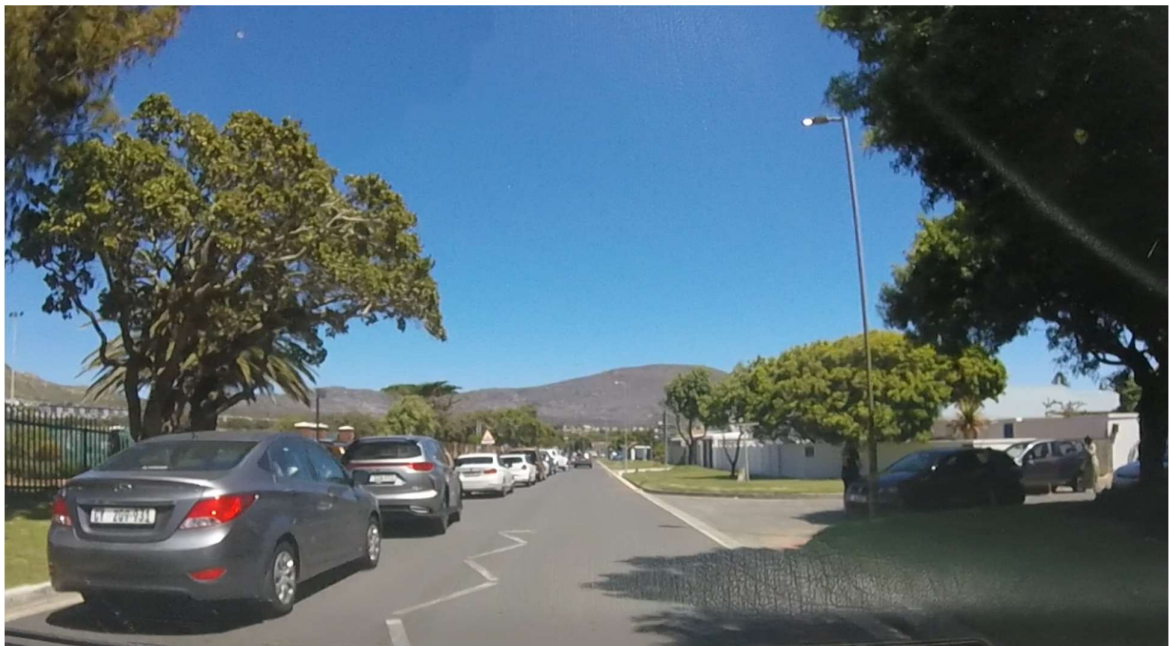
Figure A14: Corvette Avenue parents park along school and side streets at Student Gate 1

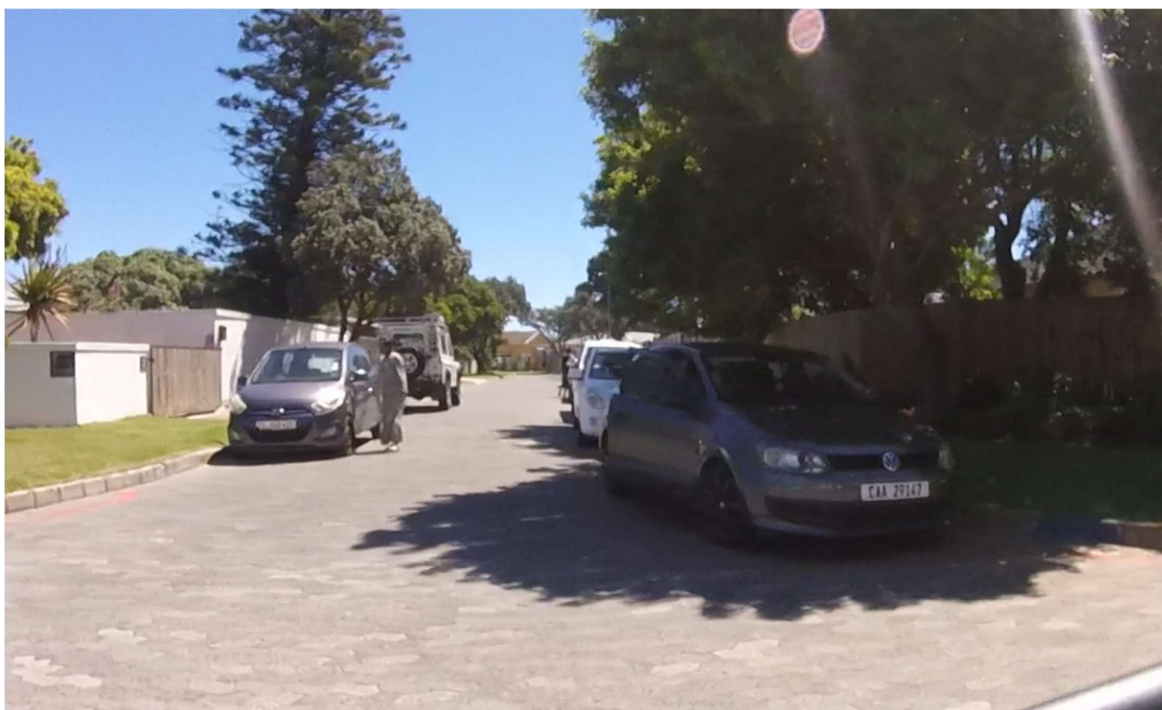
Figure A15: Parents parking along side street (Galleon Crescent) perpendicular to Corvette Avenue, close to Student Gate 1

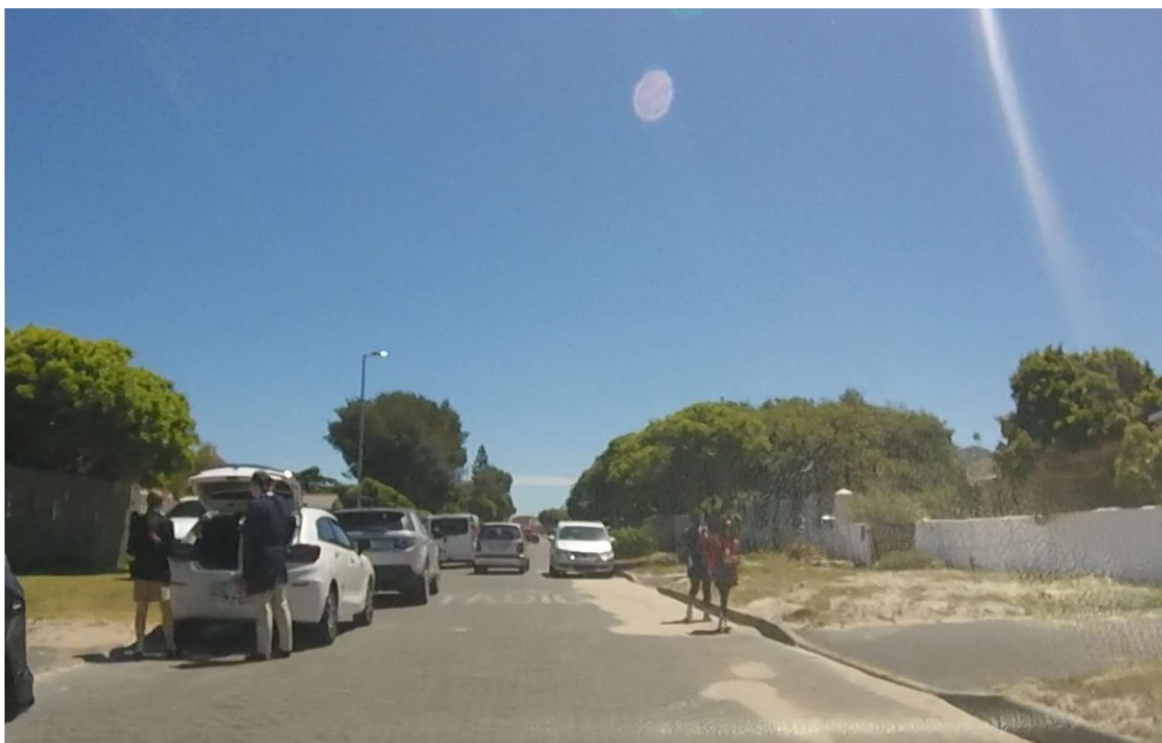
- There was traffic cones placed along Corvette Avenue to avoid vehicles from parking on the pedestrian crossing. There are no proper NMT facilities along Corvette Avenue in the form of sidewalks or universal access at pedestrian crossing (refer to Figure A16).

Figure A16: Learner observed walking in the road along Brigantine Avenue close to Student Gate 3 and Silvermine Academy

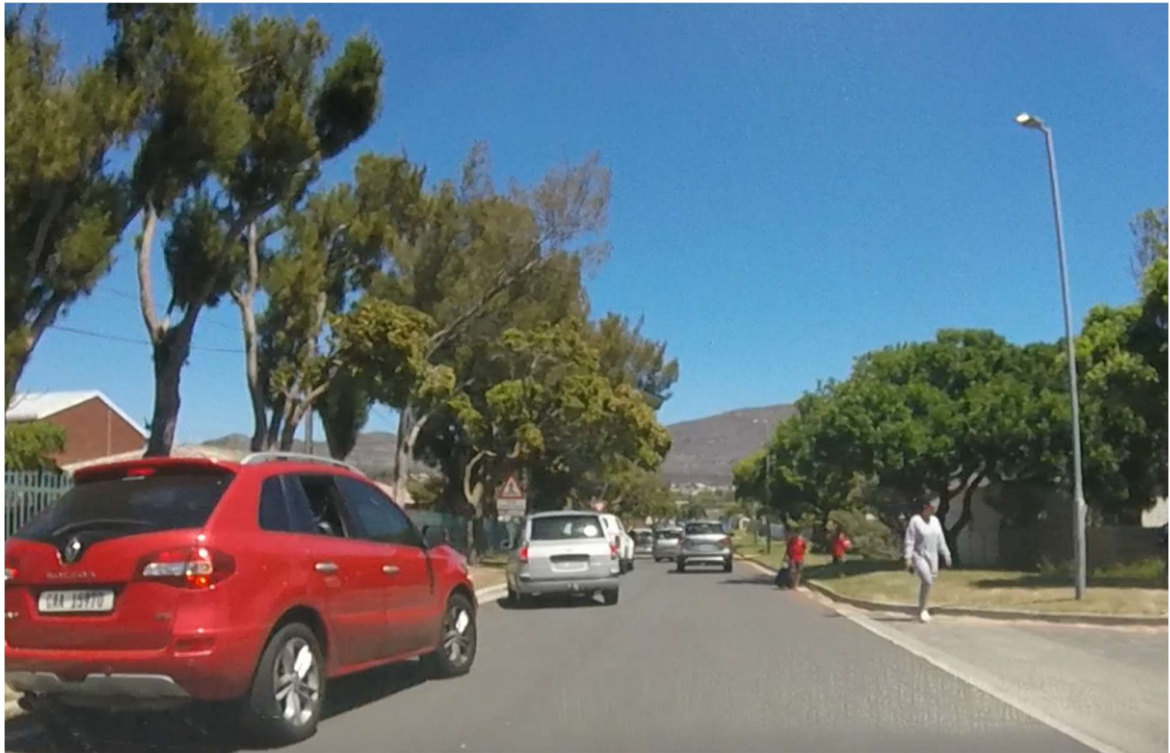
Figure A17: Raised Pedestrian Crossing in Corvette Avenue at Student Gate1 has no universal access or sidewalks.
